MiX 4000 – Time synchronisation

Description of the problem

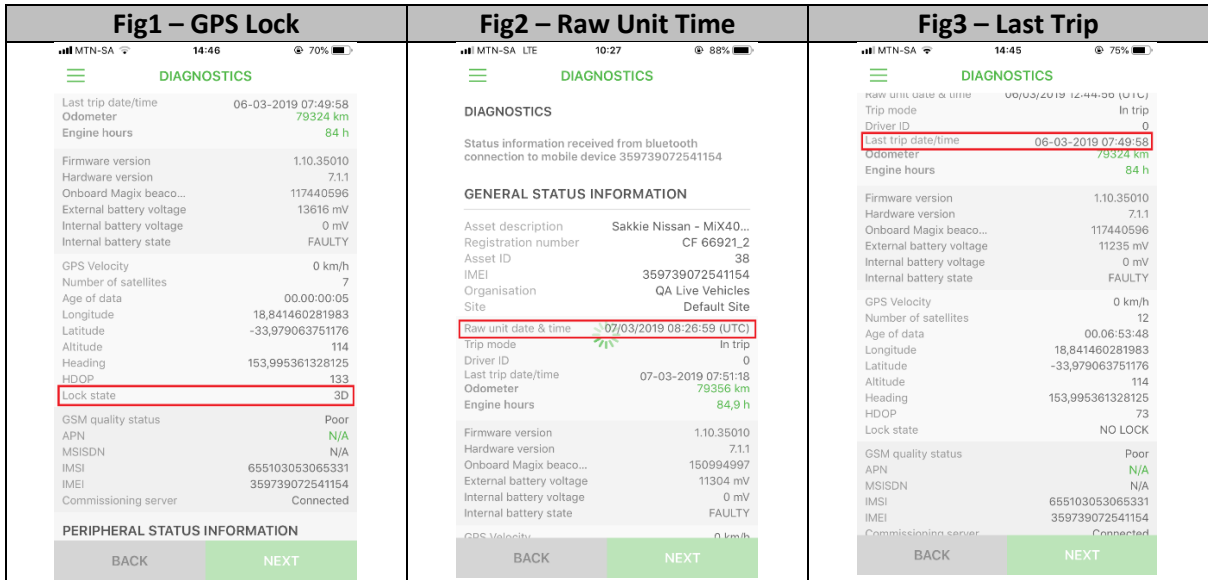
The MiX 4000 hardware is fitted with a Real Time Clock (RTC) and this clock is running faster than real-time (a few seconds per hour). In the operational system, the RTC is synchronized with GPS time (real-time) at the end of every trip and therefore a fast running clock is not ordinarily a problem visible to users.

When a MiX 4000 is powered up for the first time it **must** get GPS lock and complete a trip in order to synchronise time. If GPS lock is not achieved during the first trip and the MiX 4000 connects to MiX Fleet Manager, this “trip” will have the incorrect time and will not be visible as expected in the system. In exceptional cases where the units have been powered up (and the RTC begins running) and then the units are subsequently returned to stores for an extended period of time (e.g. as a result of a stock firmware upgrade) the unit could be running up to 1 -2 hours ahead of real time.

- 1) Ensure the MiX 4000 unit has power
- 2) Switch **Ignition ON**
- 3) Use the MiX TechTool to check that the unit **GPS has 3D Lock** (Fig1). If lock is not achieved in 60 seconds the installation needs to be repositioned or an external antenna should be fitted. This will require configs to be updated and uploaded.
- 4) When GPS Lock is achieved, switch **Ignition OFF**
- 5) Use the MiX TechTool to ensure that the “**Raw Unit Time**” is the correct real-time (Fig2)
- 6) If the Unit Time is still incorrect, repeat steps until the raw unit time is correct.
- 7) When the time is correct, ensure the “**Last Trip**” time shows correctly (Fig3). *Note this time is UTC so you have to allow for time zone offset.* If “**Last Trip**” trip time is incorrect repeat the steps to generate a valid test trip.
